DEBRIS/ICE/TPS ASSESSMENT  
AND  
PHOTOGRAPHIC ANALYSIS  
OF  
SHUTTLE MISSION STS-32R

January 9, 1990

Gregory N. Katnik  
NASA/Kennedy Space Center  
TV-MSD-22

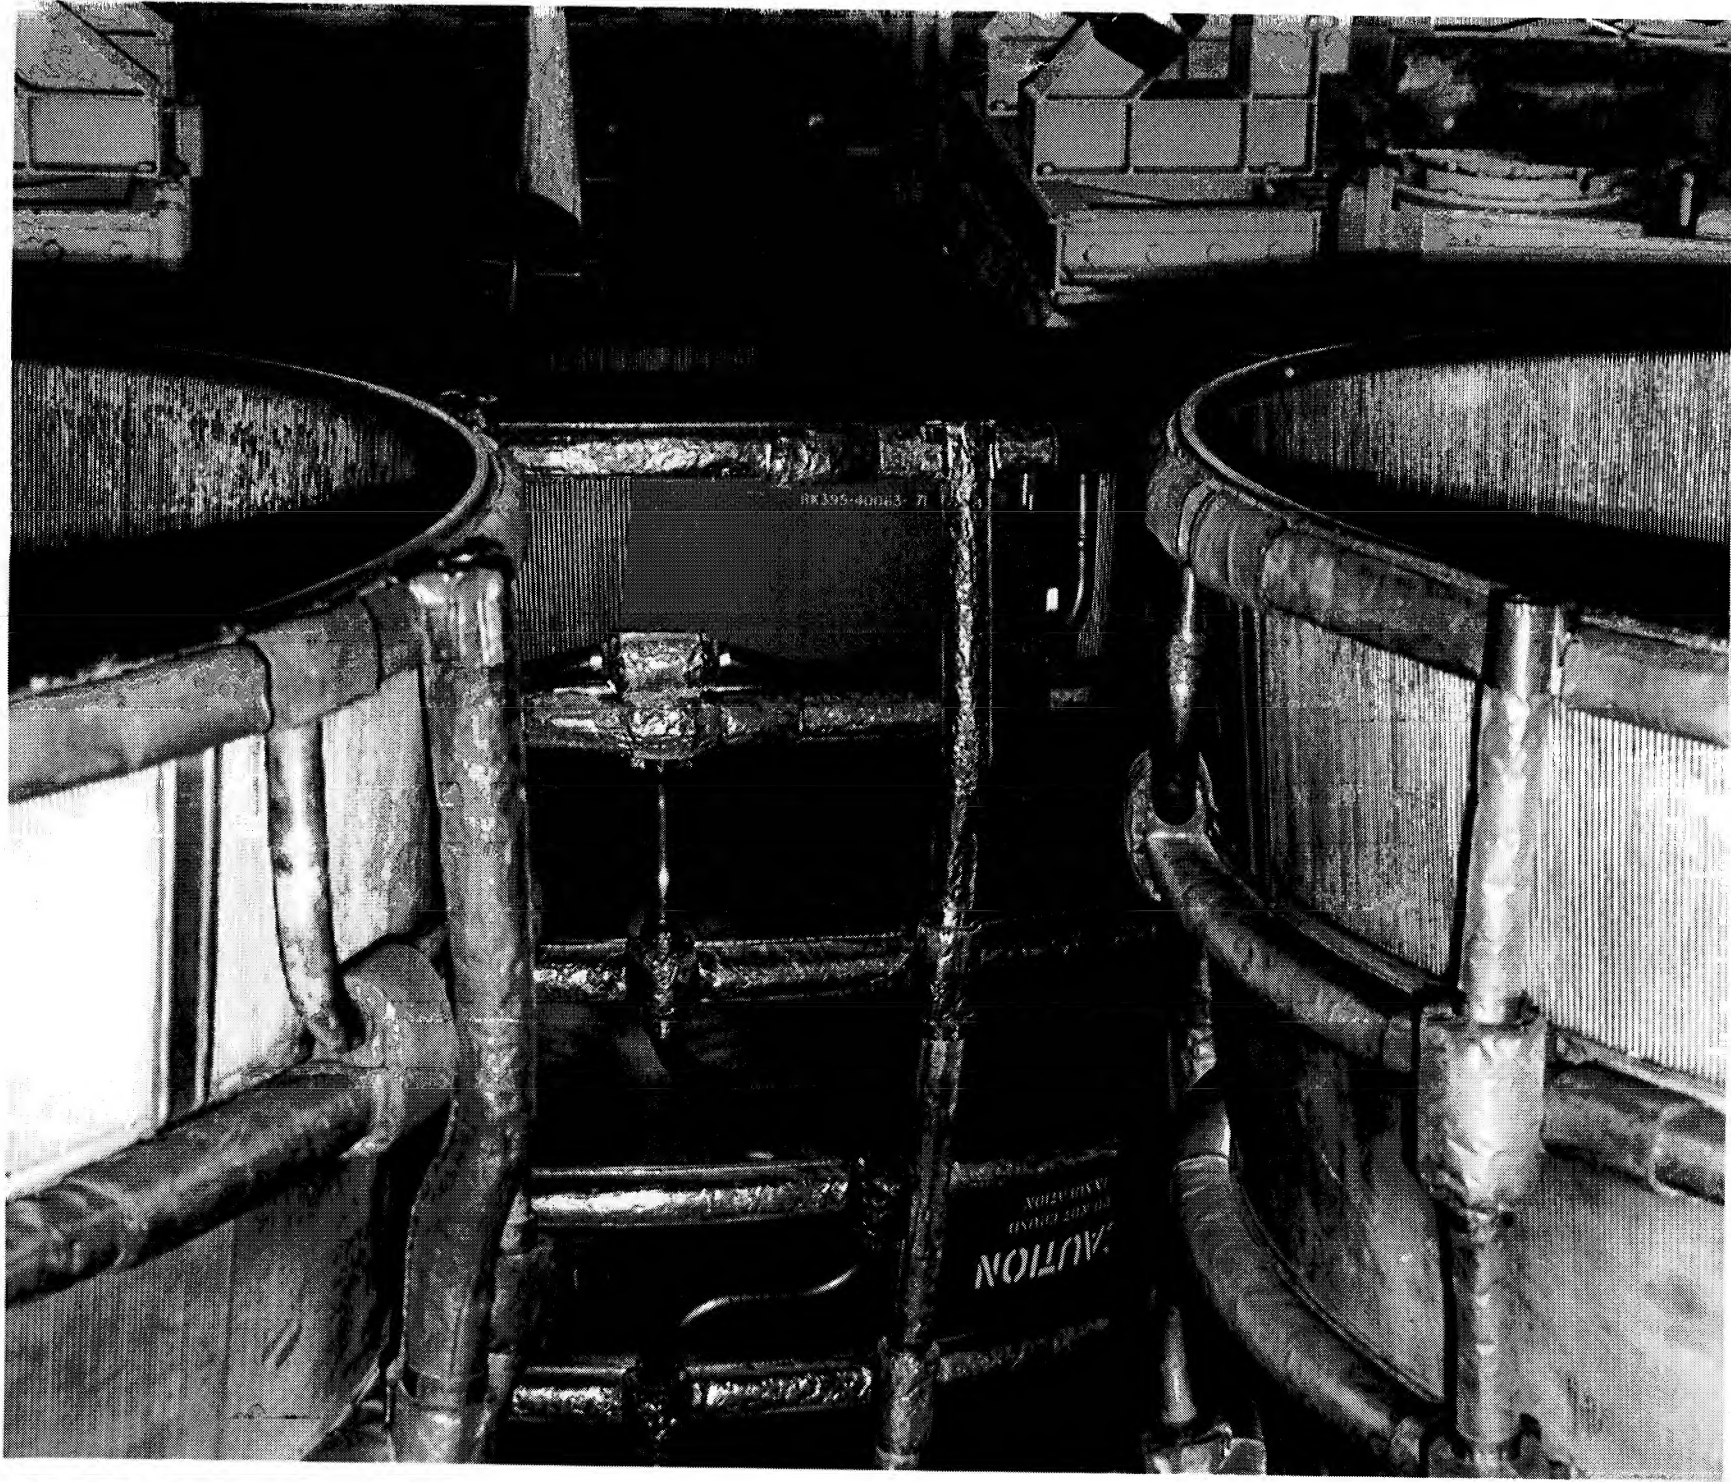
Red GSE cover on SSME #1 was removed prior to cryoload

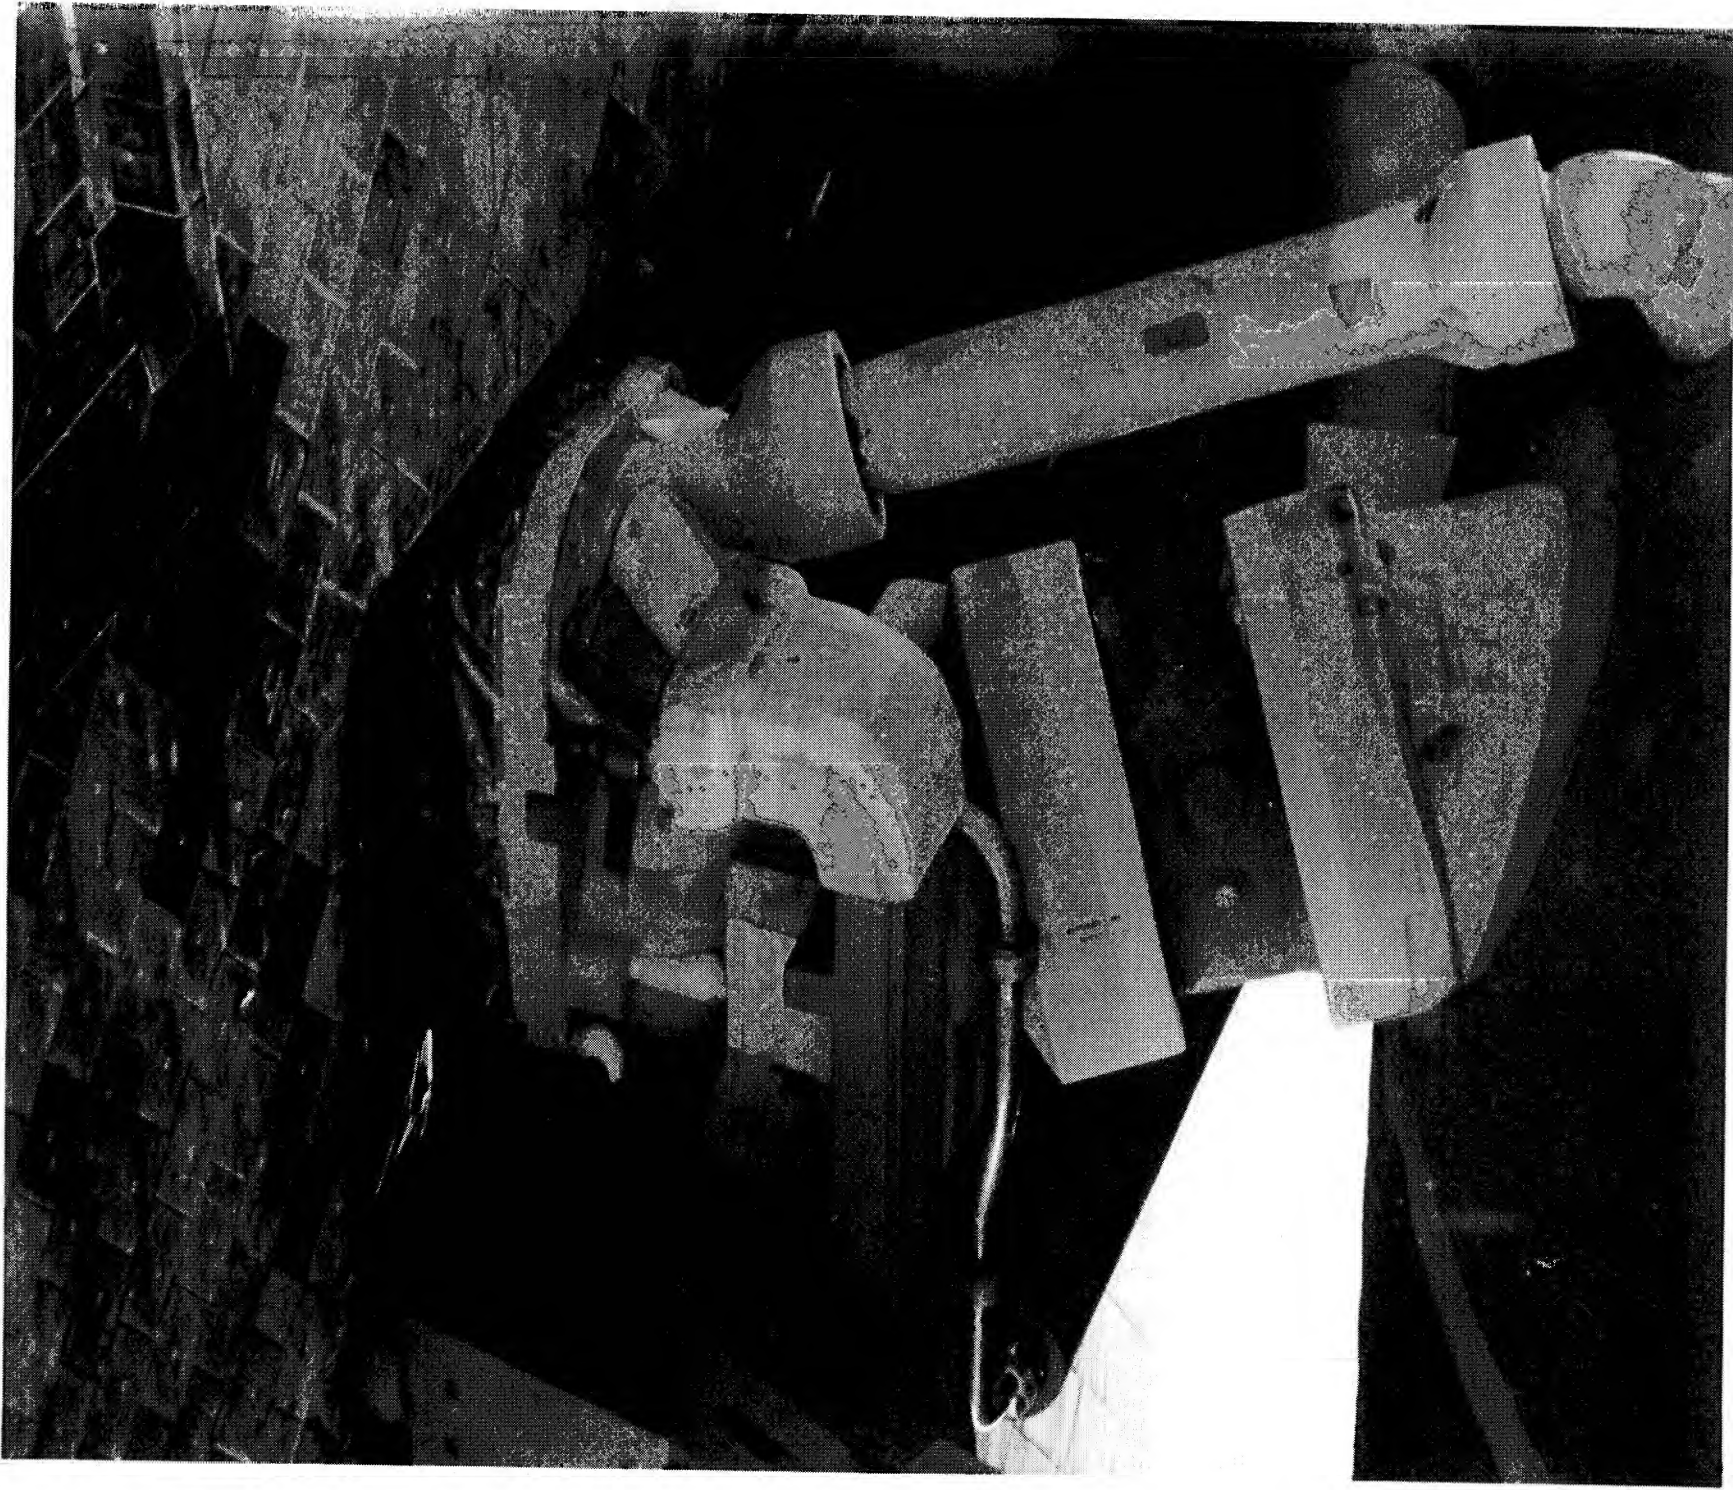
Hard ice remained on the LH2 ET/ORB umbilical purge vents  
after the tank had been drained

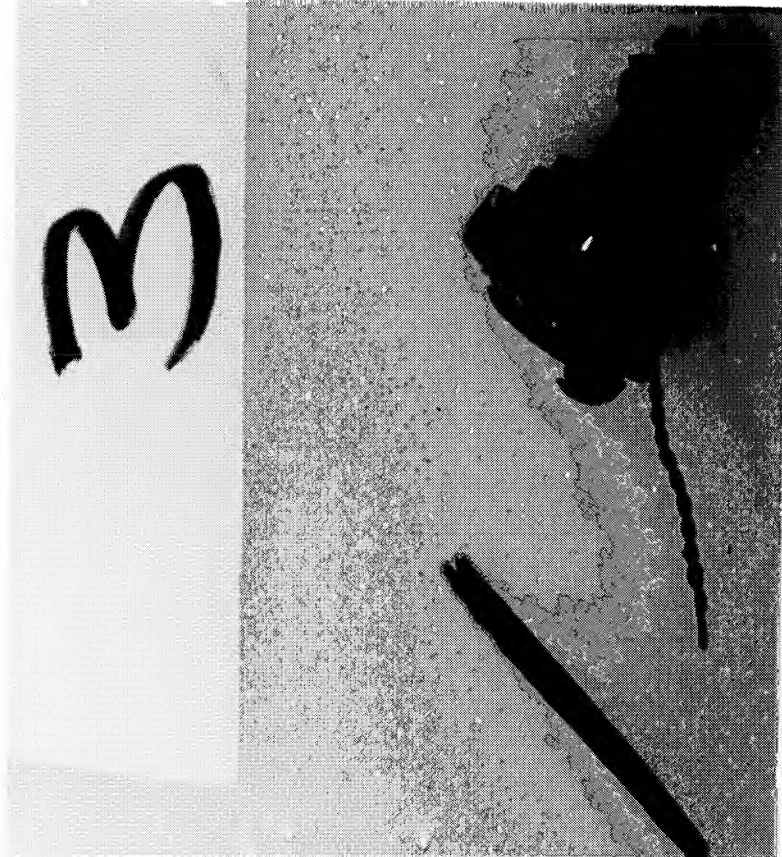
Examination of RH SRB holddown post sandboxes revealed  
an NSI cartridge and pieces of frangible nut

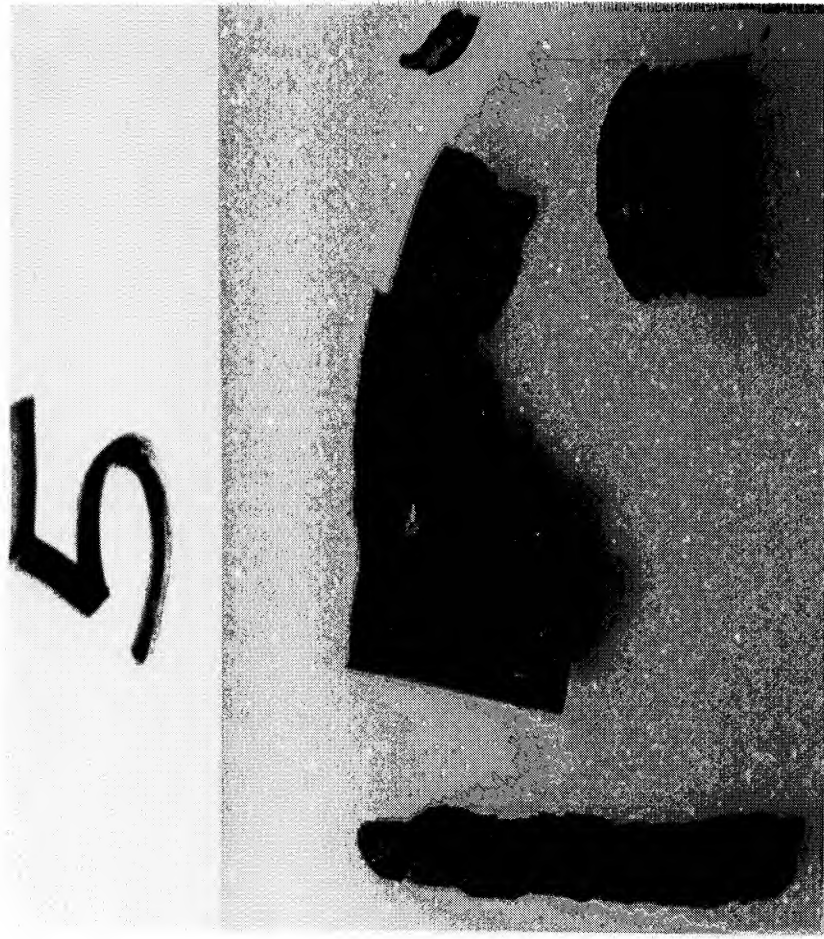
The quantity of DCS debris lost during this launch is considered by the Debris Team to be unacceptable and a potential unnecessary hazard to the vehicle.

Examination of LH SRB holddown post sandboxes revealed  
pieces from NSI cartridges and frangible nuts

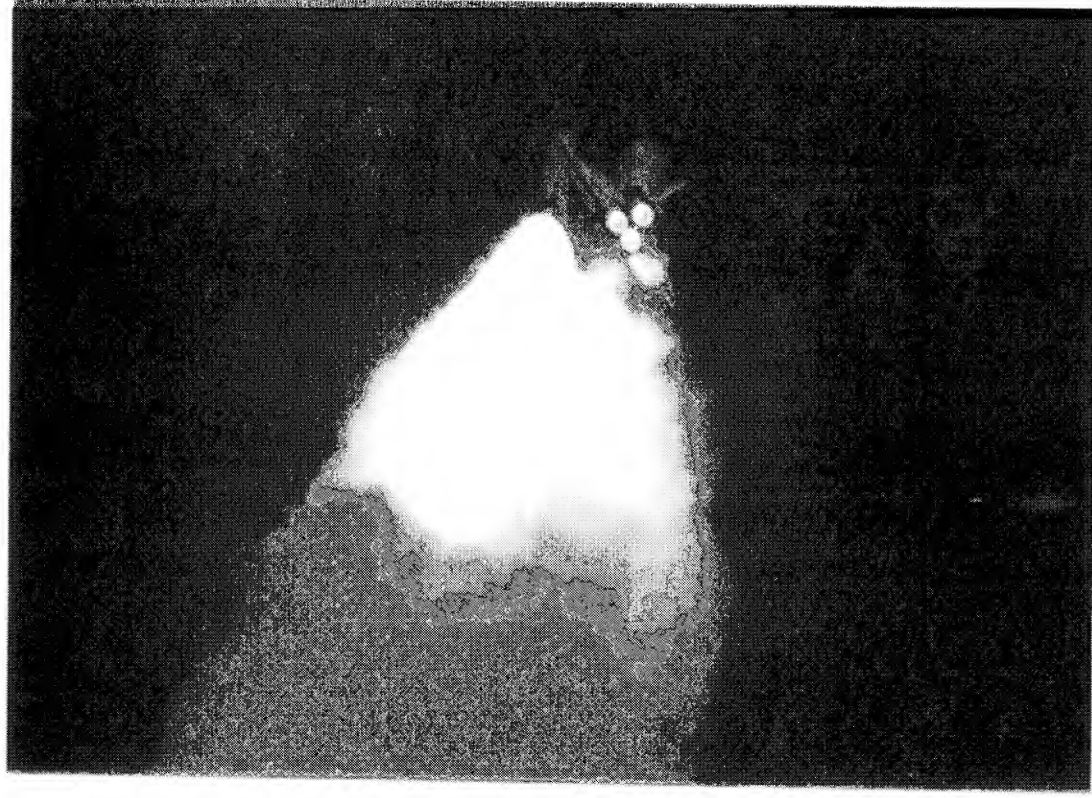
A flash occurred in the SSME plume at 43 seconds MET

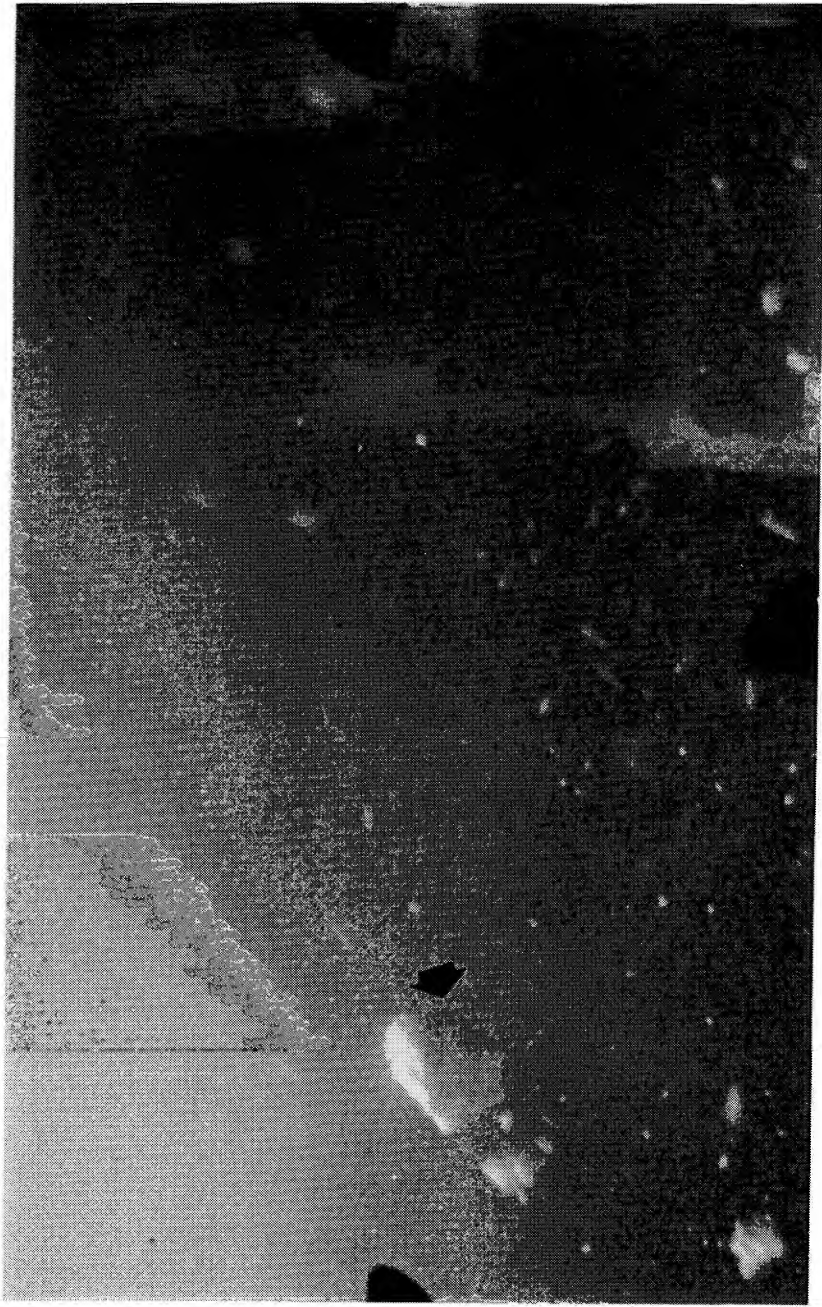
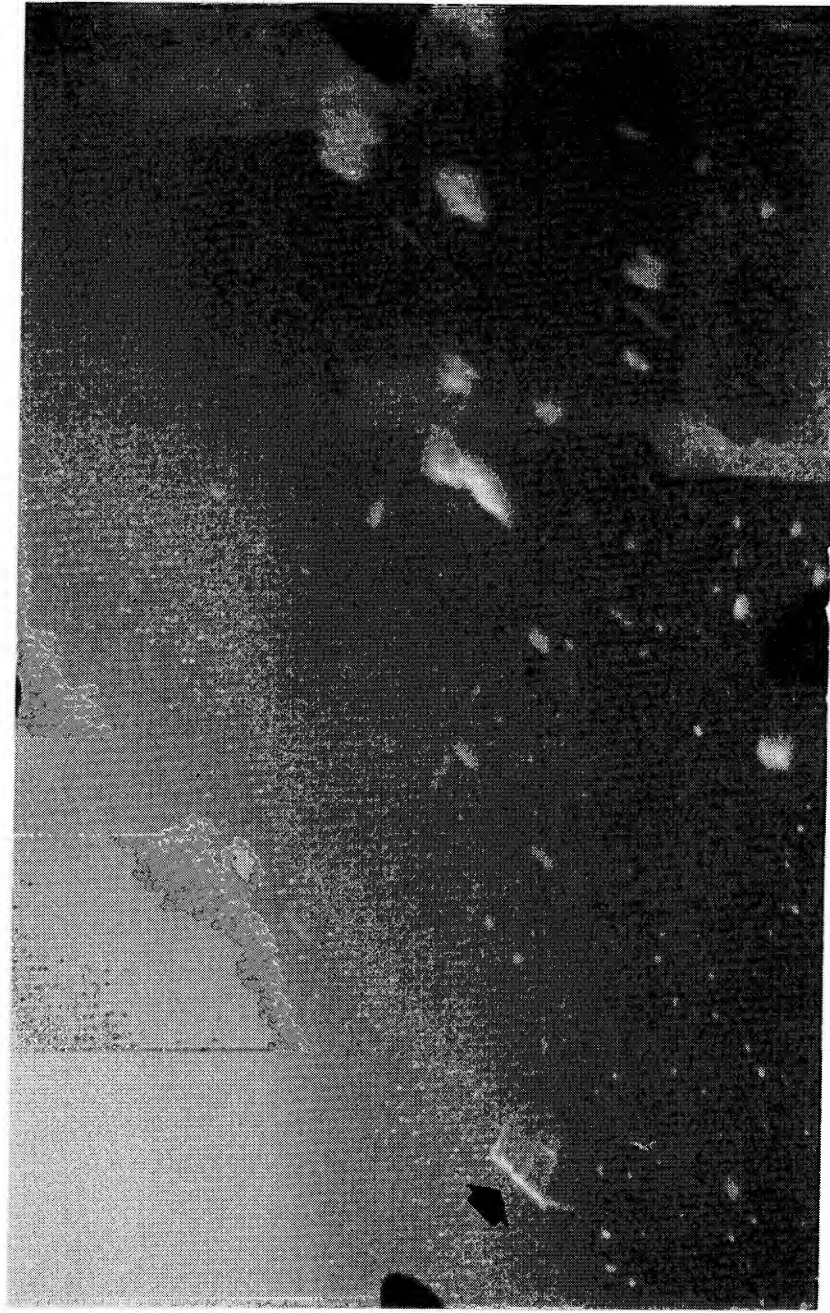
Some of the TPS from the ET intertank divots exhibits dark ring  
or isochem, as well as structural impressions

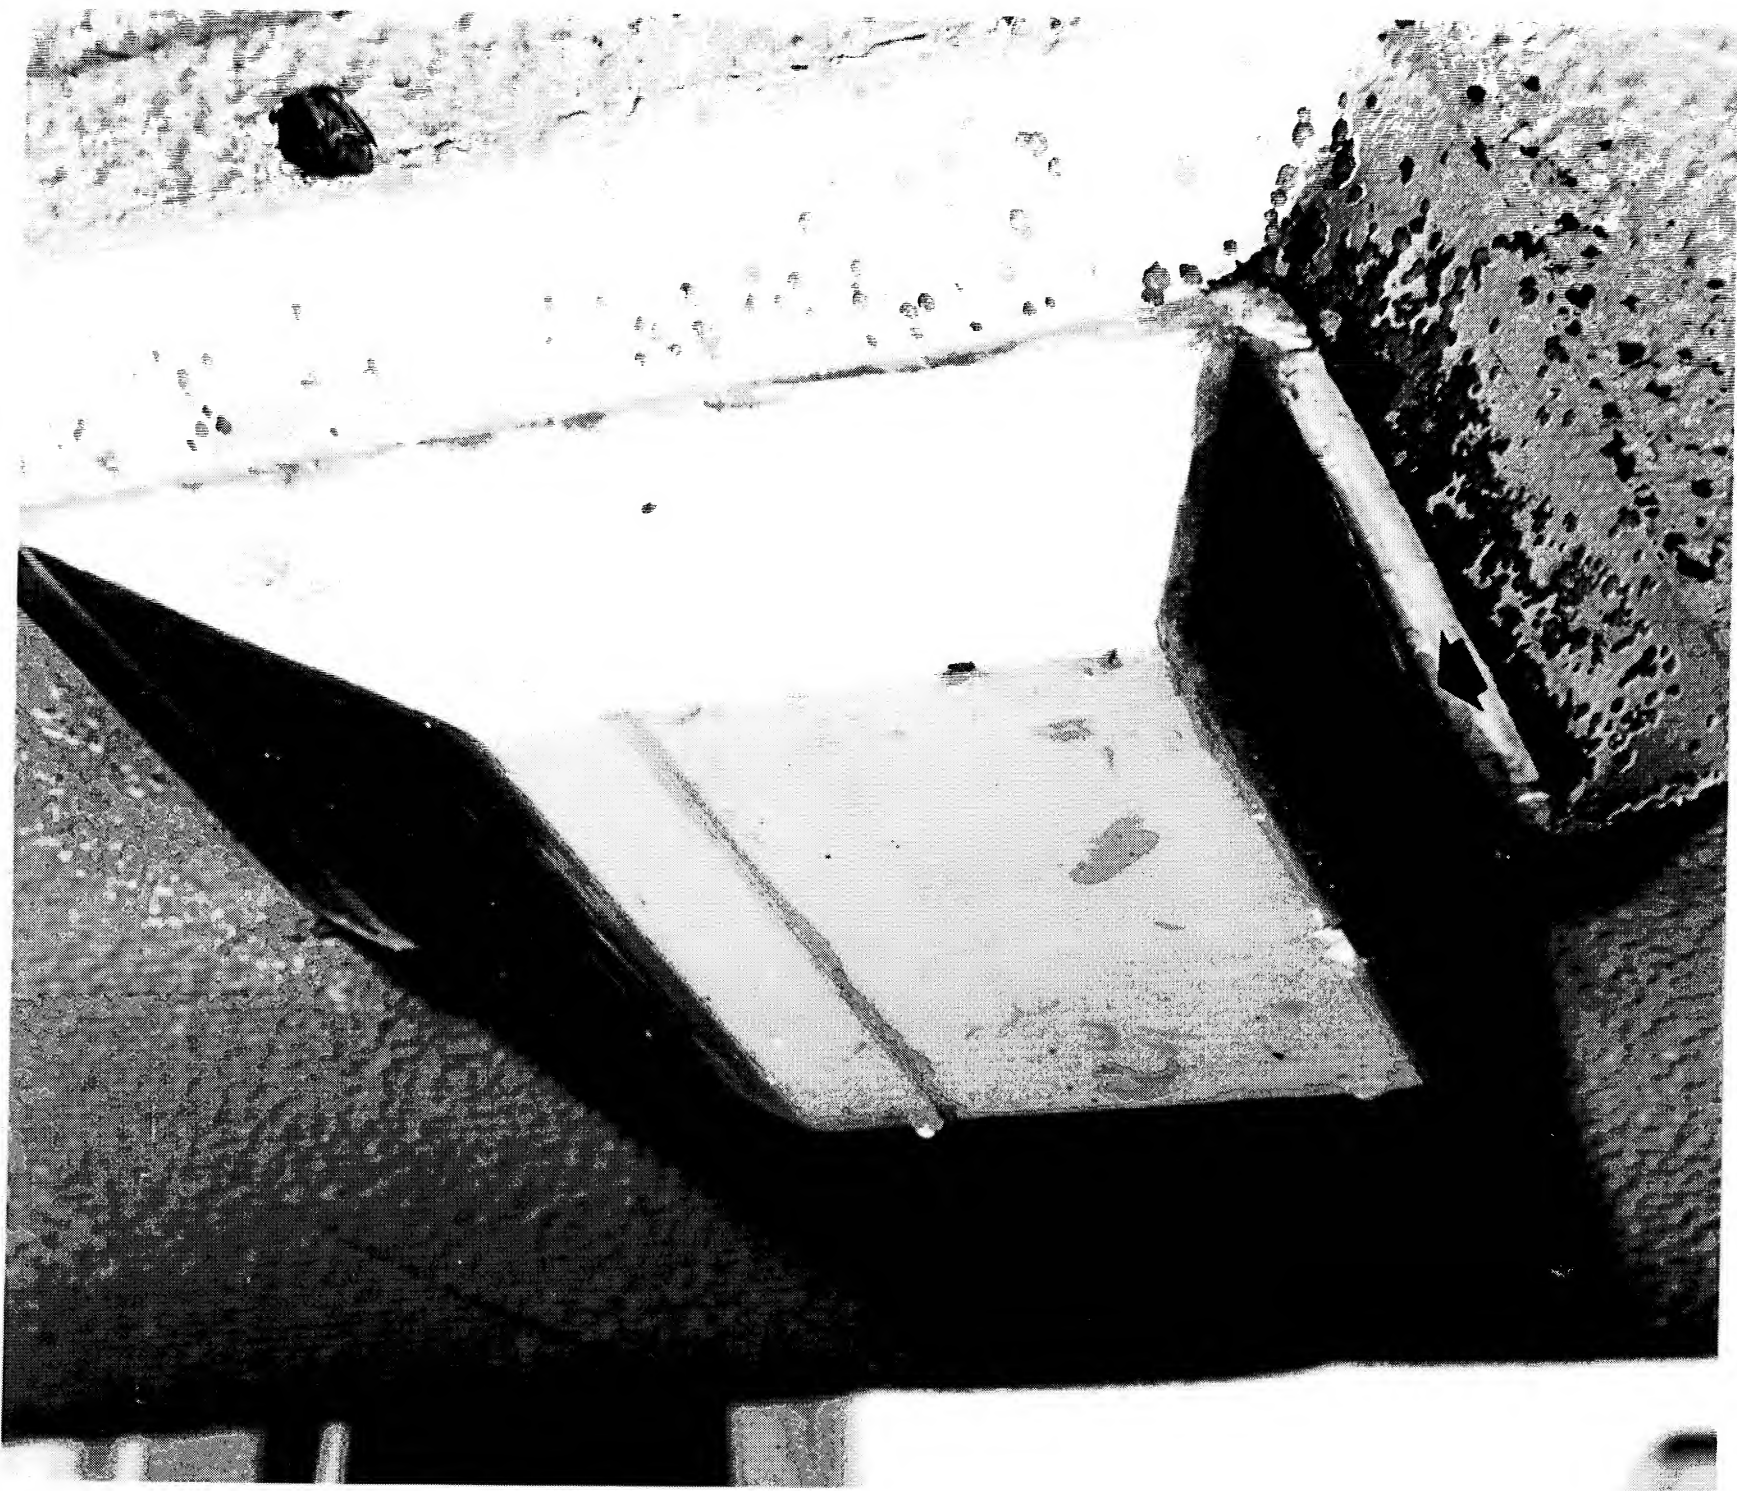
LH SRB +Z RSS antenna phenolic plate lost some material  
from the delaminated layers

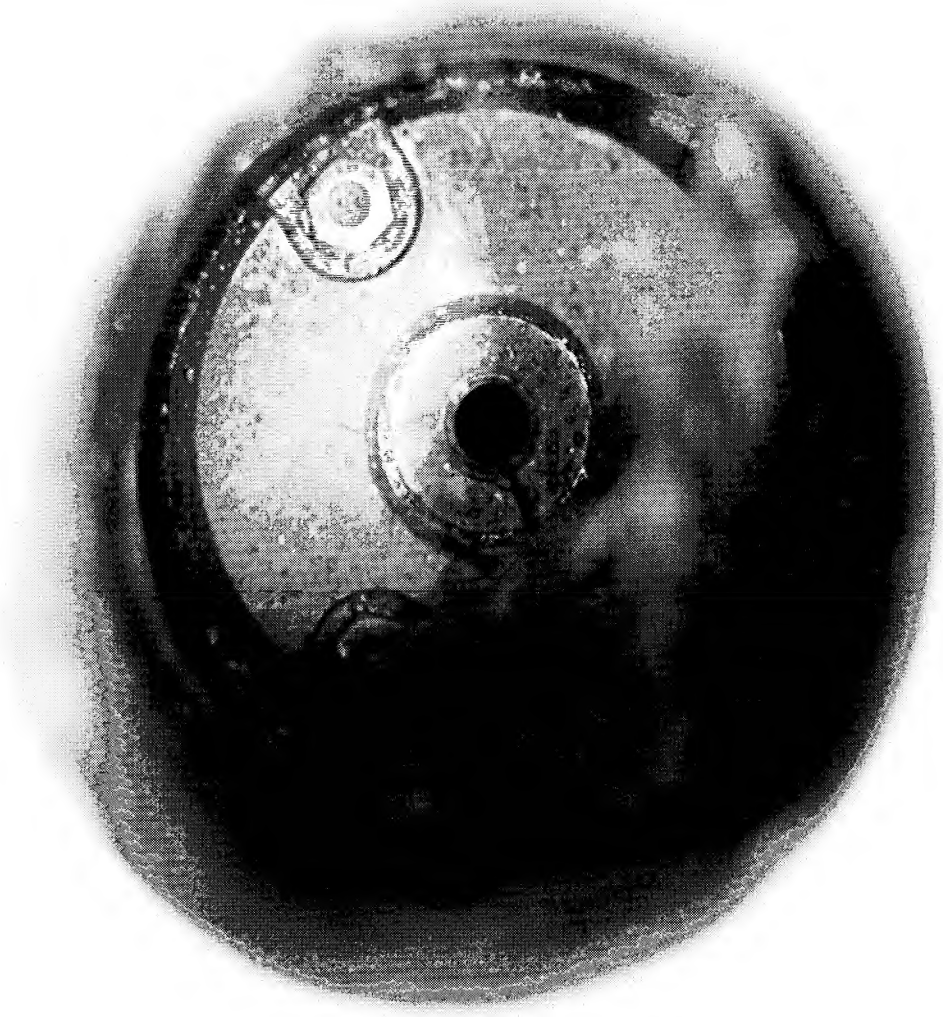
The HDP #5 and #6 plungers were seated, but the spherical washers were offset. The HDP #7 plunger was not seated and the spherical washer was displaced. Debris chunks were jammed against the plunger and one loose piece of debris (1"x1/2"x1/4") lay in the bore. A piece of thermal curtain was caught between the HDP #8 seated plunger and the spherical washer. This probably occurred during water impact, but the plunger would not have been latched.

Piece of SRB aft skirt thermal curtain pinched between HDP #8  
debris plunger and spherical washer

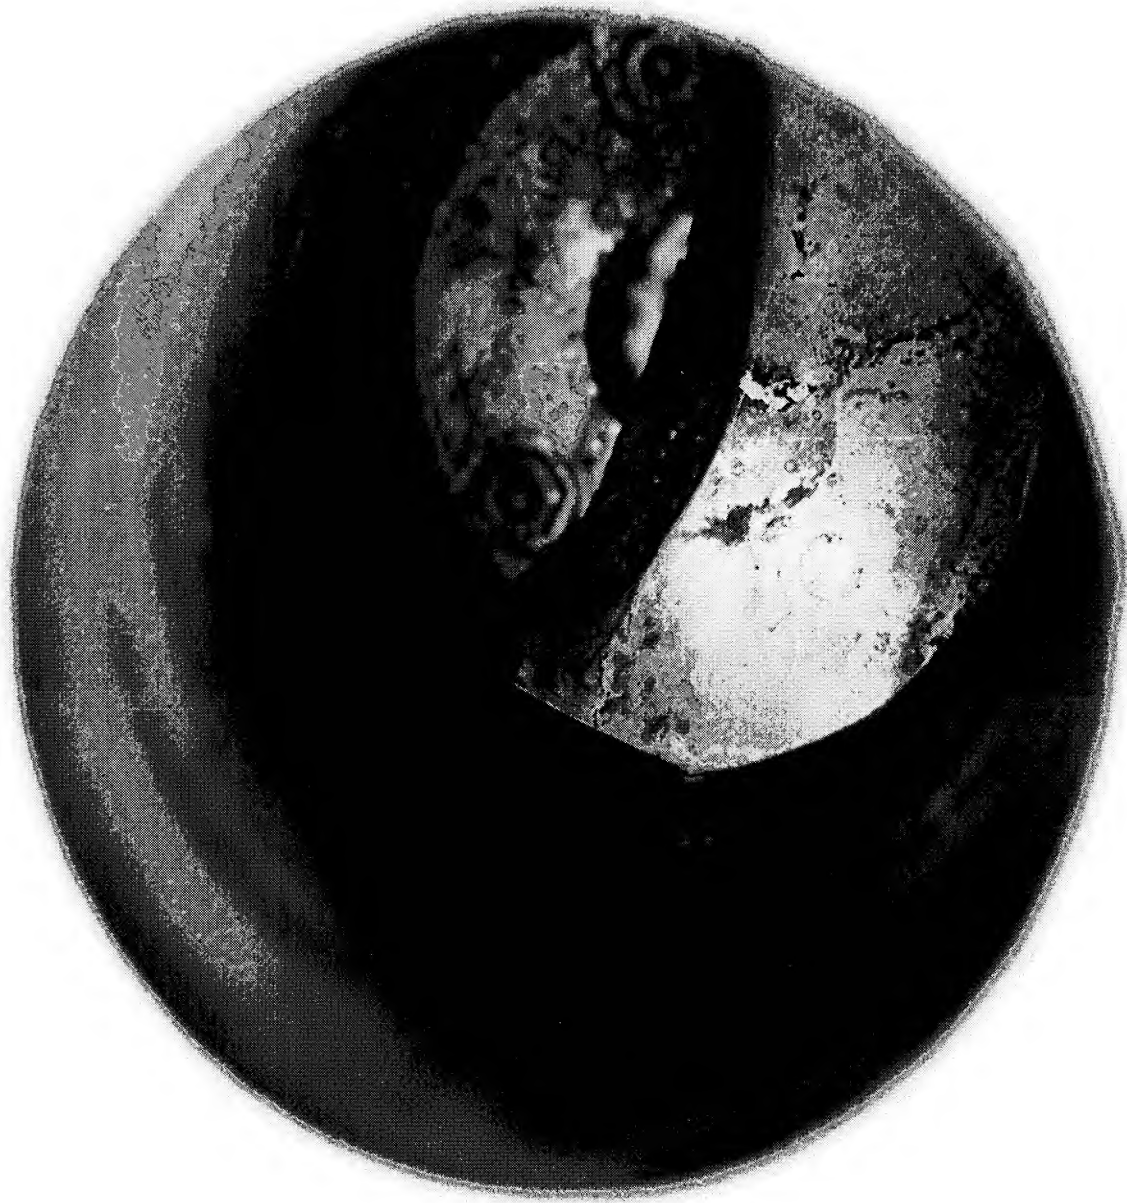
Half of a frangible nut is wedged against the HDP #1 debris  
plunger in the aft skirt stud hole

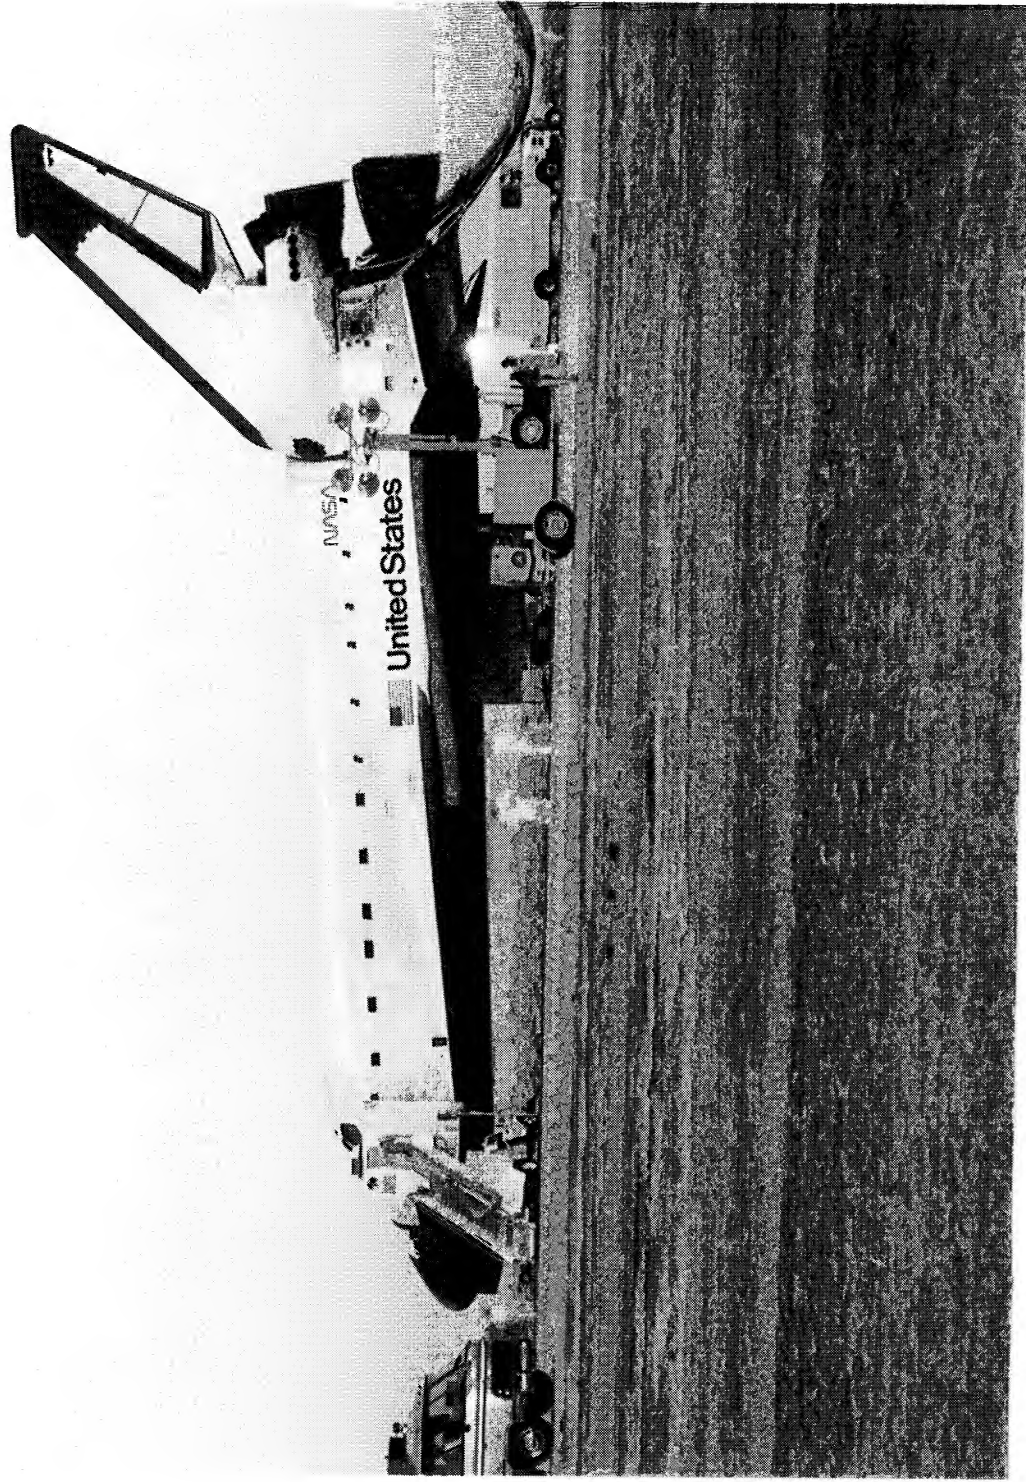
Overall view of Orbiter left side after landing
